Visual Defect Survey: Case Study of RCC Structure

M. A. D'Cruz

Civil Engineering Department, AISSMS College of Engineering, Pune, India

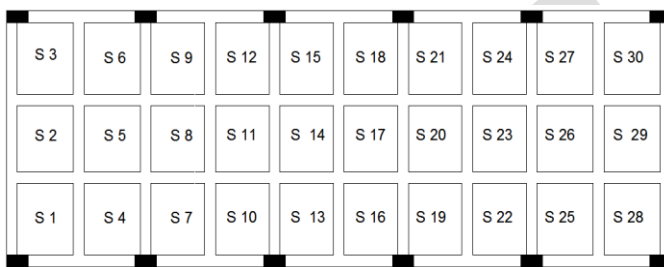
Fig. 1. Slab numbering as per inspection

ELEMENT NO.	VISUAL DEFECT
SLAB 1	Water leakage found Shuttering wood leftovers visible
SLAB 2	Shuttering wood leftovers visible Water leakage found
SLAB 3	Shuttering wood leftovers visible Water leakage found-severe
SLAB 4	Water leakage found-very severe Slab blackened due to moss/water
SLAB 5	Water leakage found Distorted shape due to bad shuttering
SLAB 6	Shuttering wood leftovers visible Water leakage found
SLAB 7	Shuttering wood leftovers visible Water leakage found Rust on surface due to leakage Distorted shape due to bad shuttering

SLAB 8	Water leakage found Slab blackened due to moss/water
SLAB 9	Water leakage found Slab blackened due to moss/water Spalling of concrete under slab Distorted shape due to bad shuttering
SLAB 10	Water leakage found-very severe Slab blackened due to moss/water
SLAB 11	Honey Combing Shuttering wood leftovers visible Water leakage found-very severe
SLAB 12	Honey Combing Shuttering wood leftovers visible Water leakage found-very severe Spalling of concrete under slab
SLAB 13	Shuttering wood leftovers visible Water leakage found-very severe Rust on surface due to leakage
SLAB 14	Honey Combing Shuttering wood leftovers visible Water leakage found-very severe Rust on surface due to leakage-bad
SLAB 15	Shuttering wood leftovers visible Water leakage found-very severe Rust on surface due to leakage
SLAB 16	Shuttering wood leftovers visible Water leakage found Rust on surface due to leakage
SLAB 17	Honey Combing Water leakage found

SLAB 18	Honey Combing Water leakage found
SLAB 19	Water leakage found Rust on surface due to leakage Distorted shape due to bad shuttering
SLAB 20	Shuttering wood leftovers visible Water leakage found Efflorescence found
SLAB 21	Shuttering wood leftovers visible Water leakage found Rust on surface due to leakage Distorted shape due to bad shuttering
SLAB 22	Water leakage found Efflorescence found Distorted shape due to bad shuttering
SLAB 23	Shuttering wood leftovers visible Water leakage found Efflorescence found Honey Combing
SLAB 24	Shuttering wood leftovers visible Water leakage found

Efflorescence found Distorted shape due to bad shuttering Slab Blackened by Fire
SLAB 25	Honey Combing Water leakage found-very severe Rust on surface due to leakage-very severe Efflorescence found
SLAB 26	Shuttering wood leftovers visible Rust on surface due to leakage
SLAB 27	Water leakage found Efflorescence found
SLAB 28	Honey Combing-severe
SLAB 29	Shuttering wood leftovers visible Water leakage found Distorted shape due to bad shuttering
SLAB 30	Honey Combing Water leakage found Rust on surface due to leakage Efflorescence found Distorted shape due to bad shuttering

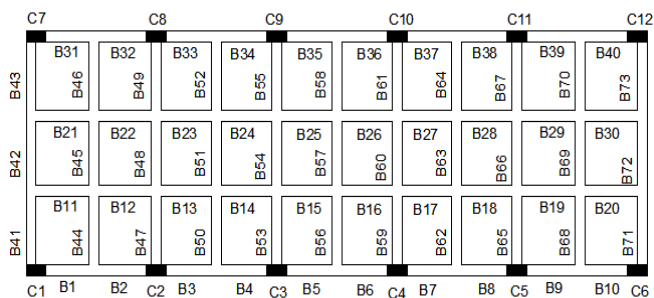
Fig. 4. Beam and column numbering as per inspection

ELEMENT NO.	VISUAL DEFECT
BEAM 1	Honey Combing Reinforcement bars visible Beam blackened due to water leakage
BEAM 2	Honey Combing Beam surface uneven - joints Spalling of Concrete-small patch
BEAM 3	Honey Combing Reinforcement bars visible Beam blackened due to water leakage
BEAM 4	Honey Combing – severe Reinforcement bars visible – severe
BEAM 5	Honey Combing Beam surface uneven – joints
BEAM 6	Honey Combing
BEAM 7	Honey Combing Shuttering wood leftovers visible
BEAM 8	Honey Combing
BEAM 9	Beam surface uneven – joints Shuttering wood leftovers visible
BEAM 10	Honey Combing
BEAM 11	Honey Combing Reinforcement bars visible
BEAM 12	Broken beam edges
BEAM 13	Honey Combing Broken beam edges
BEAM 14	Broken beam edges
BEAM 15	No Visible Defect
BEAM 16	Broken beam edges
BEAM 17	Broken beam edges
BEAM 18	No Visible defect
BEAM 19	Reinforcement bars visible Broken beam edges
BEAM 20	Honey Combing
BEAM 21	Honey Combing

BEAM 22	Broken beam edges
BEAM 23	Honey Combing
BEAM 24	No Visible defect

BEAM 25	Reinforcement bars visible Broken beam edges	BEAM 46	Reinforcement bars visible
BEAM 26	Honey Combing	BEAM 47	Honey Combing Reinforcement bars visible Shuttering wood leftovers visible Beam surface uneven – joints
BEAM 27	Honey Combing - Severe Reinforcement bars visible-severe	BEAM 48	Cover much below requirement Honey Combing-severe Reinforcement bars visible-severe
BEAM 28	Honey Combing Reinforcement bars visible	BEAM 49	Reinforcement bars visible Honey Combing Shuttering wood leftovers visible
BEAM 29	Reinforcement bars visible Blackened by Fire Shuttering wood leftovers visible	BEAM 50	Water leakage found Honey Combing
BEAM 30	Shuttering wood leftovers visible Bulging due to bad shuttering	BEAM 51	Honey Combing Shuttering wood leftovers visible
BEAM 31	Water leakage found Shuttering wood leftovers visible	BEAM 52	Honey Combing Water leakage found
BEAM 32	Water leakage found Shuttering wood leftovers visible	BEAM 53	Honey Combing Shuttering wood leftovers visible Reinforcement bars visible Water leakage found

BEAM 33	Honey Combing	BEAM 54	Honey Combing Water leakage found
BEAM 34	Honey Combing Shuttering wood leftovers visible Reinforcement bars visible Beam blackened due to water	BEAM 55	Honey Combing Shuttering wood leftovers visible Water leakage found Cover below requirement
BEAM 35	Cover below requirement Reinforcement bars visible	BEAM 56	Honey Combing-Severe Shuttering wood leftovers visible Reinforcement bars visible-Severe
BEAM 36	No visible defects	BEAM 57	Honey Combing Shuttering wood leftovers visible Reinforcement bars visible
BEAM 37	Honey Combing Cover below requirement Reinforcement bars visible Shuttering wood leftovers visible	BEAM 58	Honey Combing Reinforcement bars visible
BEAM 38	Honey Combing Cover below requirement Reinforcement bars visible Blackened by Fire	BEAM 59	Honey Combing Shuttering wood leftovers visible
BEAM 39	Traces of wood shuttering found	BEAM 60	Shuttering wood leftovers visible

BEAM 40	Shuttering wood leftovers visible	BEAM 61	Honey Combing Bulging due to bad shuttering
BEAM 41	Honey Combing Cover below requirement Reinforcement bars visible Shuttering wood leftovers visible	BEAM 62	Honey Combing-very severe Cover much below requirement Shuttering wood leftovers visible Reinforcement bars visible-rusted
BEAM 42	Honey Combing Cover below requirement Reinforcement bars visible Shuttering wood leftovers visible	BEAM 63	Honey Combing Shuttering wood leftovers visible Reinforcement bars visible
BEAM 43	Honey Combing Reinforcement bars visible Shuttering wood leftovers visible Water leakage found	BEAM 64	Reinforcement bars visible Blackened by Fire
BEAM 44	Cover much below requirement Honey Combing-severe Reinforcement bars visible-severe	BEAM 65	Honey Combing Water leakage found-severe
BEAM 45	Honey Combing Water leakage found

BEAM 66	Honey Combing Shuttering wood leftovers visible-B Reinforcement bars visible
BEAM 67	Reinforcement bars visible
BEAM 68	Honey Combing Water leakage found
BEAM 69	Shuttering wood leftovers visible Water leakage found
BEAM 70	Bulging due to bad shuttering
BEAM 71	Honey Combing Reinforcement bars visible Shuttering wood leftovers visible Water leakage found
BEAM 72	Honey Combing Shuttering wood leftovers visible Bulging due to bad shuttering
BEAM 73	Honey Combing Reinforcement bars visible Bulging due to bad shuttering

ELEMENT NO.	VISUAL DEFECT
COLUMN 1	Honey Combing Blackened by Fire Column projection bars rusted*
COLUMN 2	Honey Combing Column projection bars rusted*
COLUMN 3	Honey Combing Columns blackened due to water Column projection bars rusted*
COLUMN 4	Honey Combing Column projection bars rusted*
COLUMN 5	Honey Combing Columns blackened due to water Column projection bars rusted*
COLUMN 6	Honey Combing Column projection bars rusted*
COLUMN 7	Honey Combing Column surface uneven – joints Column projection bars rusted*
COLUMN 8	Honey Combing Column surface uneven – joints Column projection bars rusted*
COLUMN 9	Honey Combing Reinforcement bars visible Column surface uneven – joints Column projection bars rusted*
COLUMN 10	Honey Combing Column surface uneven – joints Reinforcement bars visible Column projection bars rusted*
COLUMN 11	Blackened by Fire Column surface uneven - joints Column projection bars rusted*

COLUMN 12	Unapproachable Column projection bars rusted*

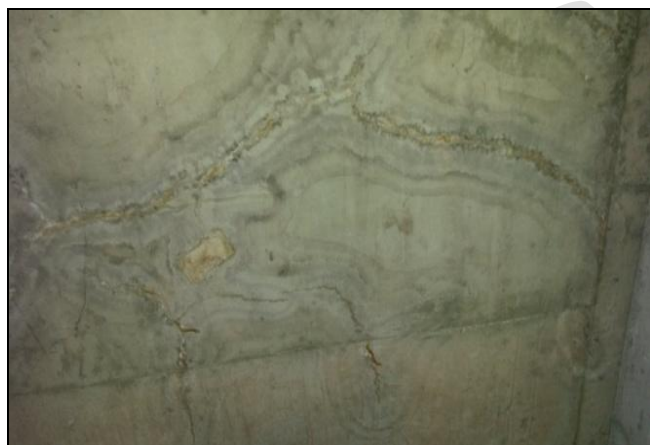
Fig. 2. Excessive leakage with rust stains visible at slab bottom

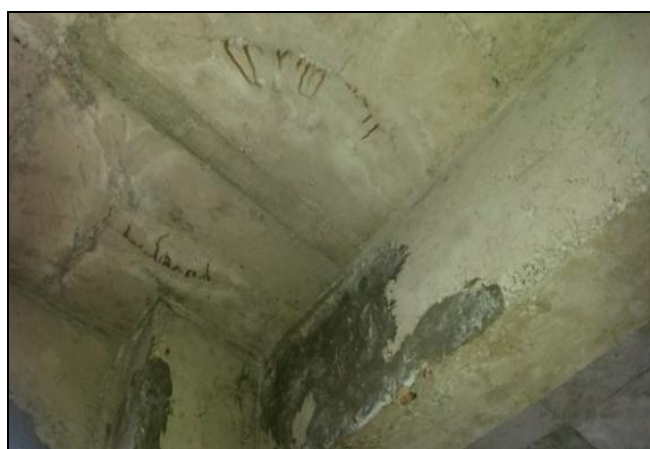
Fig. 3. Honey combing hidden with cement paste, slab leakage, uneven slab surface with rust stains clearly visible

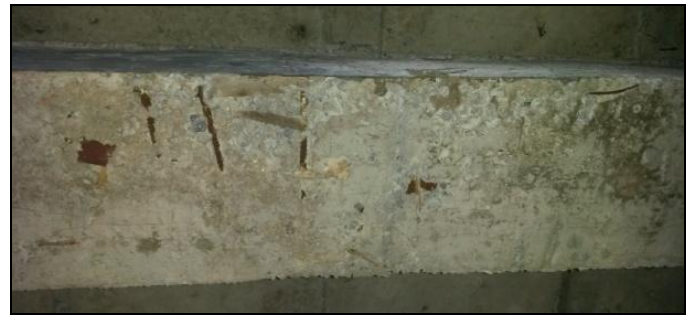
Fig. 8. Beam bottom found with piece of wood and honey combing

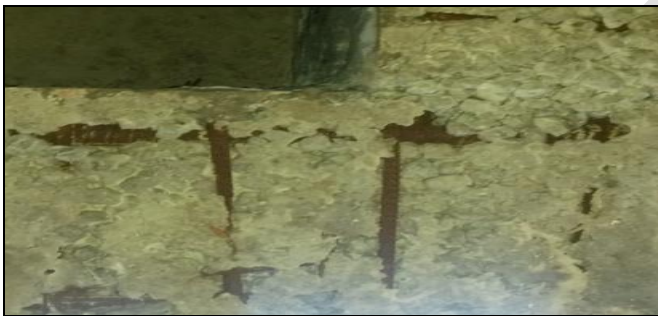
Fig. 5. Beam-beam junction badly affected by loss of cover, honey combing and exposed reinforcement

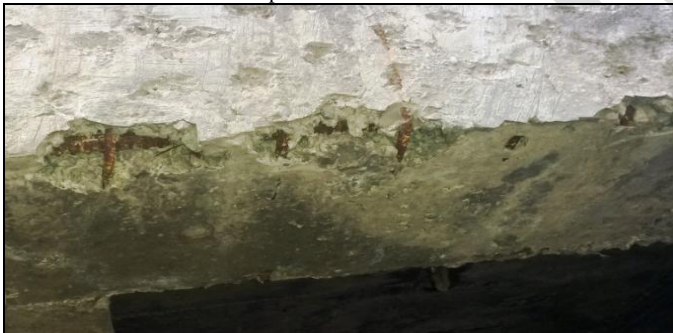
Fig. 6. Beam affected by broken edges and exposed reinforcement

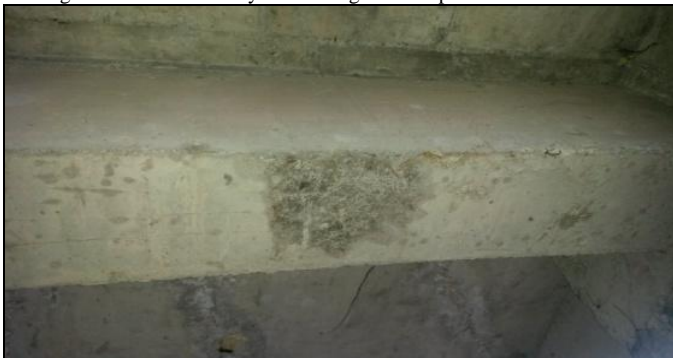
Fig. 7. Beam bottom found with traces of moss formation

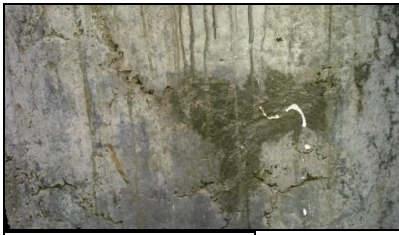
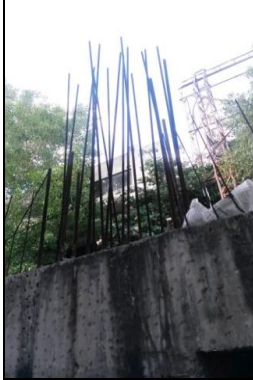
Fig. 9: Column affected by severe honey combing, hidden by cement paste
Fig. 10: Column with stains of moss due to moisture and exposed reinforcement bars completely corroded
