Application of Remote Operated Vehicle as a Post Construction Instrumentation for an Existing Dam- A Case Study

Alex Varughese

Central Soil and Materials Research Station, New Delhi- 110016

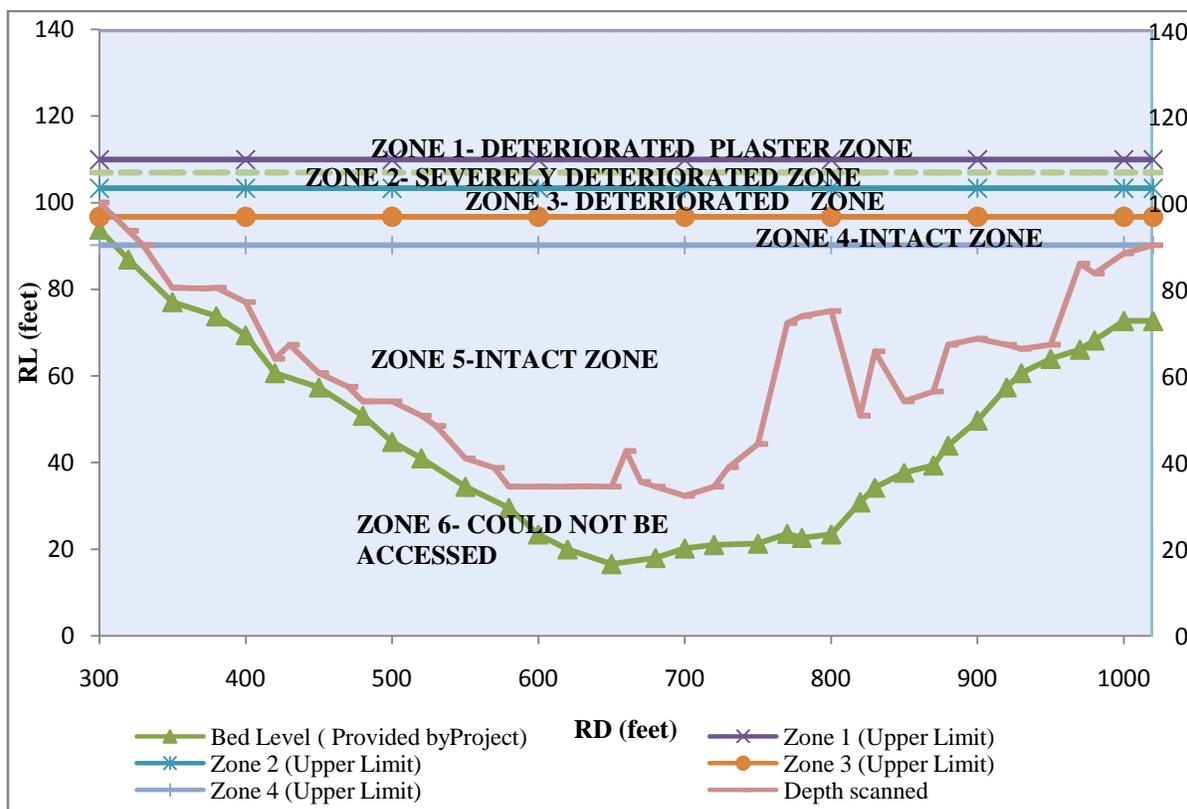
Fig 5.2 Summary of the Results (upstream face of the dam)

The analysis of the images helped divide the upstream surface into six zones based on the relative scale of deterioration. (Fig. 5.2)[1] The first (FRL-32.3ft to FRL-42.1ft) second (FRL-42.1ft to FRL-21.7ft) and third (FRL-21.7ft to FRL-55.3ft) zone were classified as deteriorated plaster zone, severely deteriorated zone and deteriorated zone. The rest of the zones were termed as intact zone. The present FRL was MWL before strengthening and MWL is 3 feet more than FRL after strengthening.

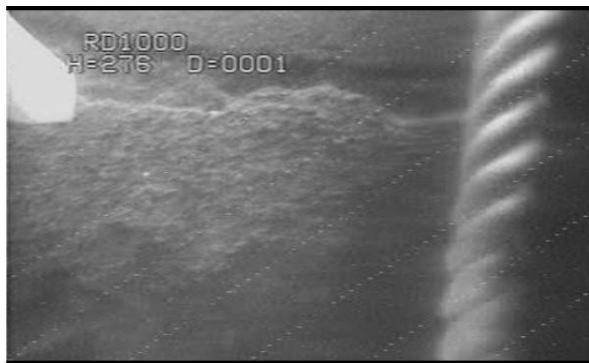
Fig 5.3 Zone 1

Zone 1-It is seen from the plot of reservoir level data made available that the water level fluctuated in this zone (Fig.5.3) at least 80 times. With this data it was not possible to draw any conclusion whether alternate wetting and drying has had effect on plaster/surface treatment or not. Further no comment can be made on the alternate wetting and drying cycles on the rubble masonry behind. But this zone has been categorized as a deteriorated plaster zone observing the present status of the u/s face.

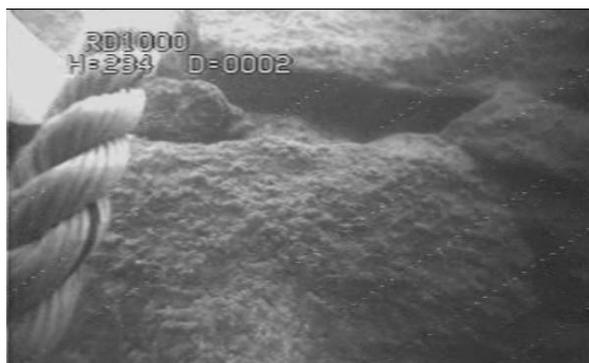
Fig 5.4 Zone 2

Zone 2-Since this zone 2 (Fig.5.4) has been categorized as ‘severely deteriorated zone’ as far as mortar in rubble masonry is concerned. An attempt was made to study the number of alternate wetting and drying cycles within this zone. From reservoir level data falling in zone 2 i.e starting from (FRL-42.1ft to FRL-21.7ft). The possible number of alternate wetting and drying cycles has been worked out in table 5.1. The table has been drawn based on pre 1981 and post 1981 basis. It is understood that strengthening measures were undertaken in 1981. The deterioration of the masonry taken place in Zone 2 is many times more than deterioration that may take place by weathering action. From these graphs we can see clearly the Zone 2 has not been subjected to enough wetting and drying for weathering action before 1981 (before

adopting strengthening measures). The zone 2 was further divided into 7 zones (2.1 to 2.7) of approximate 1 ft width .After 1981 a maximum of 30 cycles to 13 cycles of wetting and drying action has taken place in Zone 2.1- Zone 2.3 which may also not be sufficient for weathering action. Between Zone 2.4 – Zone 2.7, from the reservoir level variation it was observed no weathering action has taken place. Keeping in view the actual observations already made about zone 2 in table 7.1 and the number of alternate wetting and drying cycles encountered it is possible to arrive at a conclusion that it may not have actually contributed to deterioration of mortar in rubble masonry.

Afterwards the maximum water level was coming down in the next years. As the deterioration of the mortar was seen in zone 2 and 3 and the same is not due to alternate wetting and drying it can be very well be concluded that tensile stresses has developed on upstream portions due to continuous bending of the dam as water level has crossed the FRL and also the dam has not been strengthened during the period. The base width of the dam at the lower limit of zone 3(Fig.4.1) was much less than the base width actually required at that location of the dam before strengthening. The possible reason for the deterioration of the mortar may be due to this bending. Deterioration of the mortar might have taken place above zone 2 also but it was not visible as those portion has subjected to pointing with cement mortar of 1:3 & plastering with cement mortar 1: 3-3/4” thick, was done whenever the old guniting had blistered. The work was done departmentally upto 1954-1965

Based on the relative scale of deterioration of upstream surface, it has been divided into 6 zones. The alternate wetting and drying cycles has not contributed towards the deterioration of mortar in the rubble masonry in Zone 2 & Zone 3. The possibility of missing mortar beyond the surface cannot be ruled out. The zones 2 & 3 have been recommended for renovation.

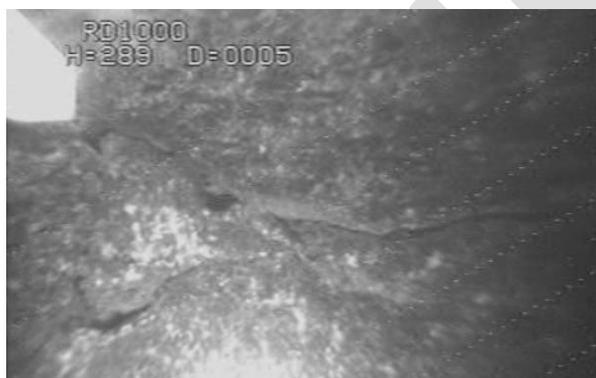
Fig 5.5 Zone 3

Zone 3- Since the lowest reservoir level recorded in the history of the dam is in Zone 2, Zone 3 (Fig.5.5) has not experienced any weathering action at all. Here also the deterioration of masonry is not due to weathering. In view of the above it was concluded that alternate wetting and drying has not contributed to deterioration of mortar. The fact that deterioration of mortar is visible in zone 2 and zone 3 (to lesser extent) and not significantly elsewhere, calls for identifying factors which might have contributed to deterioration.

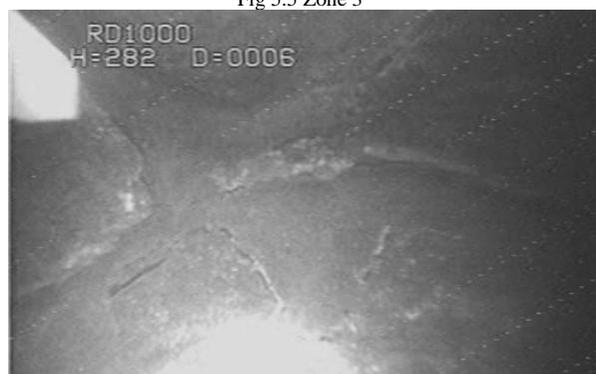
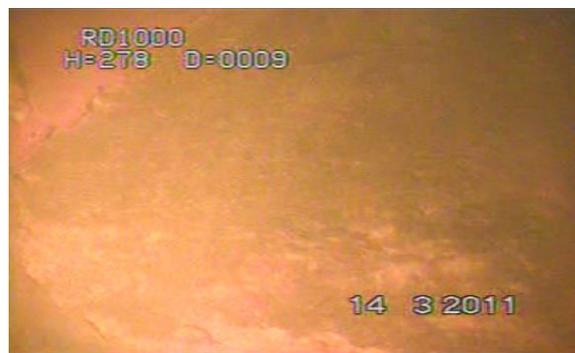
Zone 4,5 & 6 -The Zone 4&5(Fig. 5.6 & 5.7) are generally intact rubble masonry from one end to other. And zone 6 was inaccessible to ROV due to debris.
