A Geospatial Approach to Flood Vulnerability Mapping for Disaster Management in Lokoja and Environs

Abstract: - Geographic information on flood vulnerability is essential for preparing for flood disasters. This study applies Geographical information System Techniques to produce flood vulnerability map of Lokoja and environs and its potential to cause devastating effect in the area. This study is aimed at mapping flood vulnerable areas within Lokoja, for an effective flood disaster management and proper planning. Satellites imageries MODIS of 2011 and 2012, SPOT 5 of 2011, location map of Lokoja Metropolis, SRTM DEM, rainfall data, water discharge/gauge data, and GPS coordinates; acquired during field survey were integrated to map areas vulnerable to flooding. The study is limited to environmental factors such as hydrology, slope, soil type, drainage density, landform and land use/land cover. Different maps were generated; composite map of the study area, flood extent map, flood plain map, slope map, flow direction map, flow accumulation map, Triangular irregular network, flood vulnerability map and also pie chart showing percentage area impacted, histogram showing the pattern of r

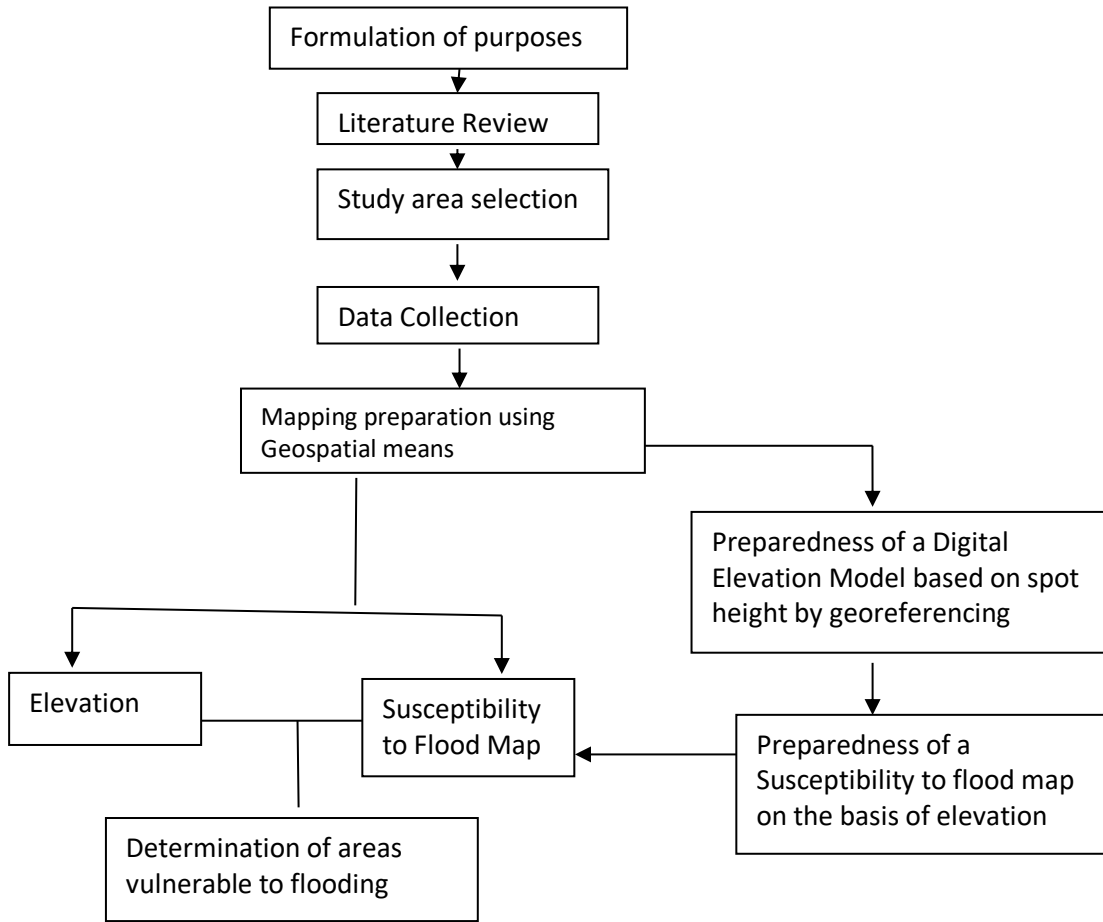
Figure 1: Research workflow

- i Data such as Satellite imageries, Satellite Radar Topographic Mission (SRTM) data, Topographic maps, and Global Positioning Satellites (GPS) points was utilized for this study. The MODIS images to be used would comprise of visible and infrared channels to better distinguish between water and land. The Geodetic/Geographical data, the settlement and Road route map was extracted from the Administrative Map using Georeferencing and Digitization Procedures.

- ii Image Processing was carried out using the Earth Resource Data Analysis Software (ERDAS) 9.2 to mosaic the Landsat ETM+ Path 189 Row 54 and Row 55 respectively. The Arc GIS 10.1 was used to perform the Supervised Classification of the Study Area to determine the Land Use and Land Cover of the terrain before flood.

- iii The Arc hydro tools of the Environmental Systems Research Institute (ESRI) was used to preprocess the Digital Elevation Image of the Study Area by producing the agreed Digital Elevation Model (DEM) and other Operation as Sink and Flow Accumulation, Data Projection and Georeferencing. Images preprocessed in other software's were imported in the Arc GIS 10.1 software where the area of interest was extracted via the clipping process in the Arc tool box. The AOI raster and Vector feature of the Lokoja town was then re-projected to WGS 1984 Universal Transverse Mercator (UTM) Zone 32 N. Mercator (UTM) and Georeference.

- iv **Field Data Integration.** Geodetic data was collected to validate the flood extent obtained from the Satellite imagery of the Study Area. This was carried out to validate the flood extent as captured by the Satellite imageries. The point data was collected by a Garmin GPS - Map 76 Mark Receiver, Canon digital Camera, Printed Copies of Satellite imageries and Base Maps was used as the field tools to identify and delineate inundated areas.

- v (e) Spatial Analysis Techniques. The analysis of the inundated areas was conducted via query by location i.e. Proximity Analysis. This was done by selecting some of river channel, and shape files of the settlement to determine areas that were adversely affected by floods. The Buffering was categorized into various ranges along the basin to represent the highly vulnerable, moderately vulnerable and safe-zone regions of the Study Area (Ojigi, 2013). This operation was carried out in ArcGIS software by loading all features layer (Point, Line and polygon) that cover the flood Inundated region to determine the actual spatial coverage and extent of the flood. The zoning of flood vulnerable areas was categorized into three zones (highly vulnerable, moderately vulnerable and safe-zone regions). This zoning was based on the proximity of communities along the River basin as well the elevation of the terrain of the study area.

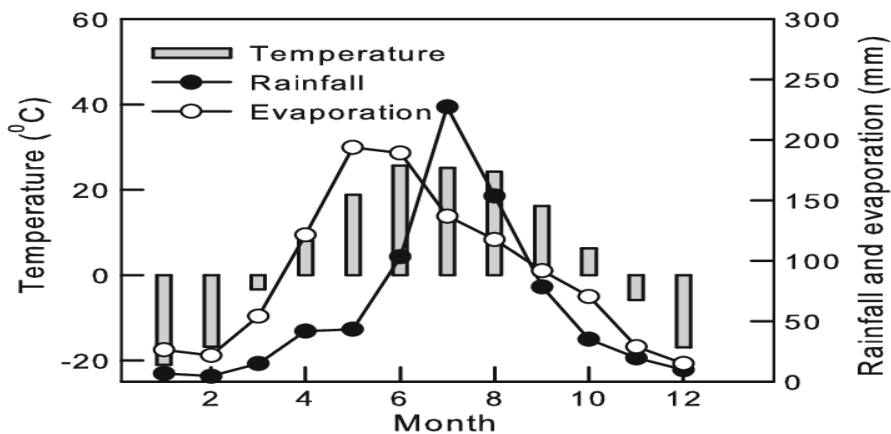
Figure 2: Mean Monthly Rainfall and Evaporation Statistics of Lokoja

Table 1 and Figure 2 indicate that highest rainfall is normally recorded in the month of August/September. Correspondingly, evaporative losses are much lower between May and October and thus signifying moisture surplus. Figure 3 illustrate the seasonal variation in the moisture availability over Lokoja. The months of November to April of any hydrological year also suffers moisture deficit. These are dry season months in the Study Area. About 6 months; May to October are also characterized by moisture surpluses corresponding with wet season period at Lokoja.

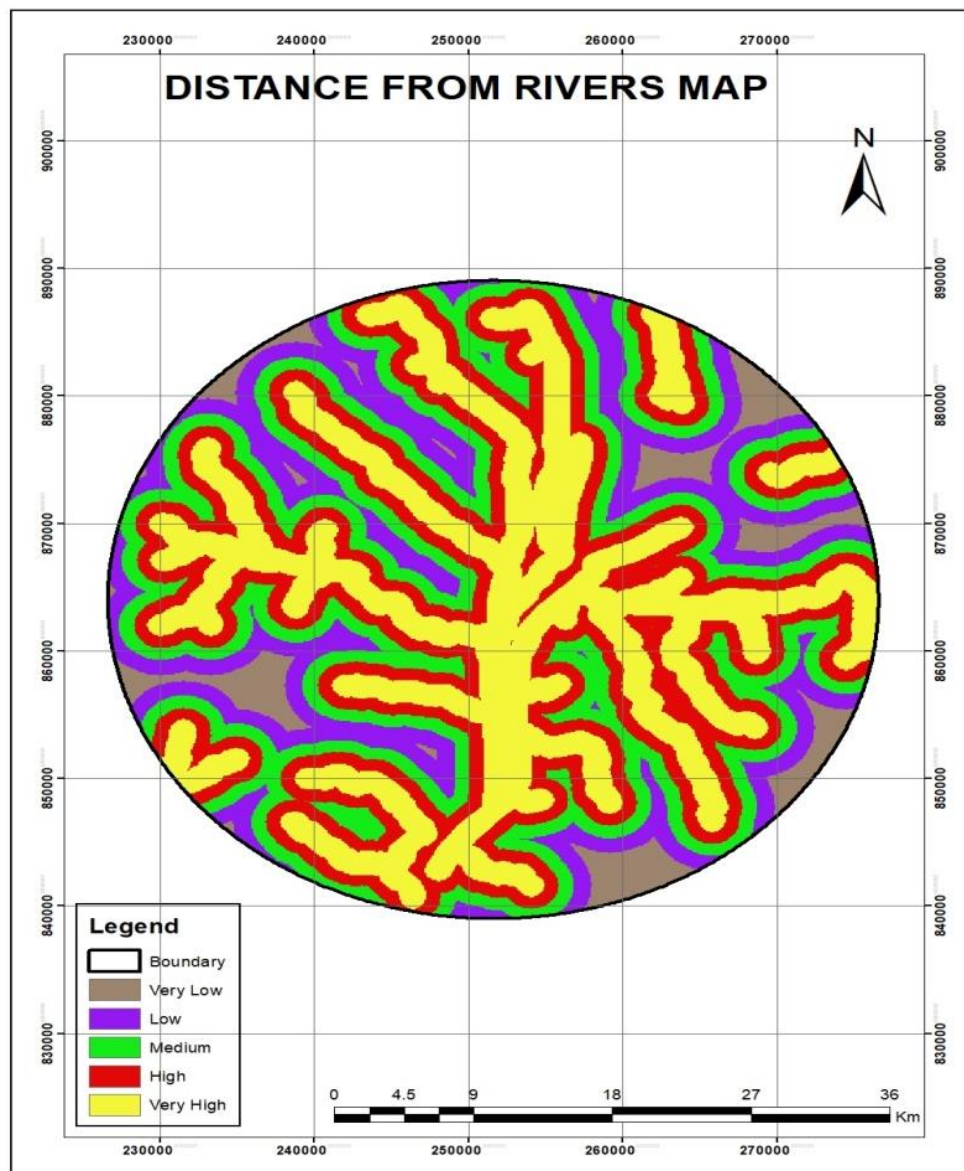
Figure 4: 1,500 Meter Buffer Distance along Drainage Lines

Figures 5, 6 and 7 shows a multiple ring buffer of the drainage basin in the following criteria 300 m, 500 and 1,500 m respectively. This was performed to determine flood risk extent in accordance with Space Standards for Urban Development and areas liable to flood along the river channel in the Study Area.
