Repair and Retrofitting of Building

Ahjoliya Dhruvi¹, Dholu Smit², Patel Ketu H.³, Tarpara Yash⁴, Patel Yash⁵, Bhavya Solanki⁶, Prof. Darshika Shah⁷
^{1,2,3,4,5,6} B.E. Student, Civil Engineering Department, Aditya Silver Oak Institute of Technology, Gujarat Technological University, Gujarat, India

A. Site Situation: -

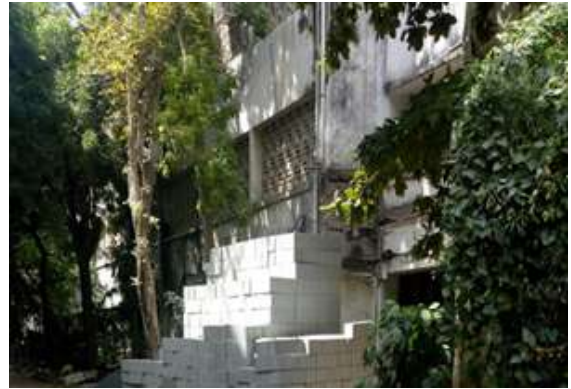
Fig-1

- The building was built in 1978. The building is situated in the campus of N.I.O.H centre, Ahmedabad.
- The structure is ground plus two floor and is R.C.C. frame structure
- Structure & leakages marks & vegetation growth was observed on ceiling, columns & beam bottom
- De- bonding concrete cover was observed on slab area at various locations.

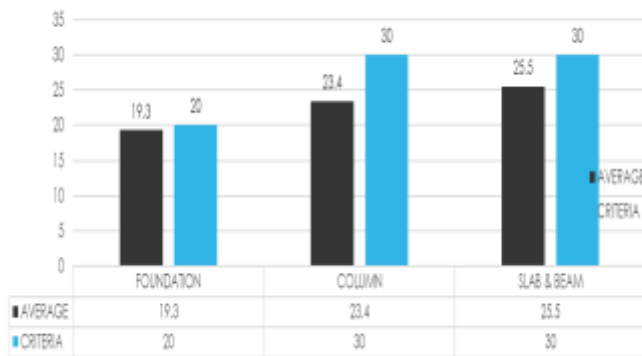
REBOUND HAMMER TEST

Average Rebound Number	Quality of Concrete
>40	Very Good Hard Layer
30 to 40	Good Layer
20 to 30	Fair
< 20	Poor Concrete
0	Delaminated

Criteria for rebound hammer test

- i. Hammer Test: -The grade of concrete was found to be lower than 30(average rebound number).
- ii. U.P.V Test: - The velocity was found to be 3 km/hr, due to presence of void in concrete.
- iii. Corrosion Test: - Reinforcement was found about 20% at risk in column and slab of building.
- iv. Carbonation Test: -The depth of carbonation was about 20-25mm in slab and whole column and footing was carbonised.

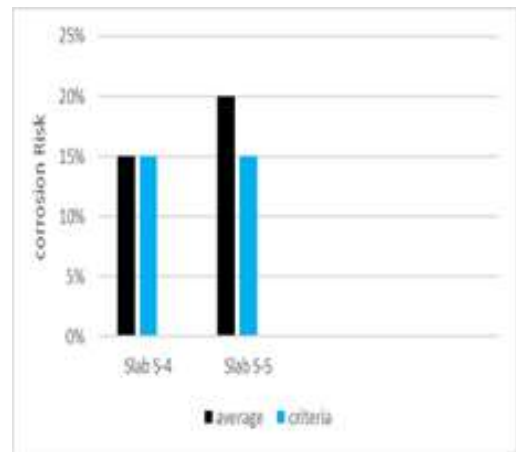
(3) Corrosion Test:

Corrosion Risk	Potential
> 95%	More Negative than - 350mV
50%	-200 to -350mV
<15%	More positive than -200mV

Criteria for corrosion test
